SubSea Solutions Newsletter "The Chronicles"

Rapid Cost-Effective Worldwide Underwater Repair Solutions

THE ART OF THE INSERT

Class Approved Permanent Hull Plate repairs

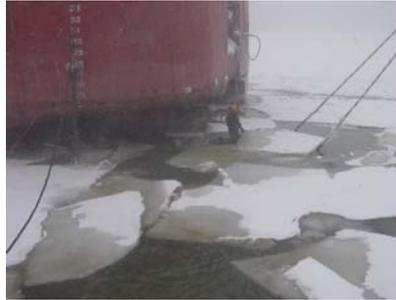
In late December the member companies of the Subsea Solutions Alliance performed 4 class approved permanent hull plate repairs throughout the world. One repair was performed when an unfortunate grounding caused significant hull damage to multiple locations in the aft section of a vessel while it transitted the Great Lakes. The Subsea Solutions Alliance member company in Canada responded accordingly. Two inserts were required in the curvature of the aft section of the Engine room. One insert measured 1.9 meters by 2 meters and the second insert measured 2 meters by 2.2 meters. The engineers within the Subsea Solutions Alliance applied their class approved weld procedures and developed a specific CLASS APPROVED PERMANENT REPAIR procedure for the vessel. Working in sub-zero temperatures in very rough sea conditions, specialized cofferdams were fabricated and installed to isolate the affect hull sections. Using welders trained and certified to the Subsea Solutions Alliance Class approved weld procedures, the two inserts were successfully installed under class supervision.

During the same period in December, repair teams from the Subsea Solutions Alliance member companies in Miami and Canada performed two CLASS APPROVED PERMANENT REPAIRS in the Gulf of Mexico. These repairs were made back to back to two vessels with damage in double bottom wing tanks; one over the turn of the bilge. The affected areas, measuring 45 cm by 30 cm, were sealed with a purpose built cofferdam. The affected areas were cropped away and new plates were inserted and welded in with certified divers to the Subsea Solutions Alliance class approved procedure.

Lastly, while all of these inserts were being installed in North America, the Subsea Solutions Alliance team in Europe was busy performing a similar insert repair on a vessel in Antwerp. Alleviating a temporary repair that was put into place by the Subsea Solutions Alliance team earlier this year, the repair team was given 3 days to crop the affected area covering 1.25 meters by 1 meter and perform a Lloyds Register class approved repair. Again, a purpose built cofferdam was installed so that the affected area could be properly cropped away and the surfaces prepared. Using a team of certified welders, the repairs were performed to Lloyds Register requirements under class supervision.
